CENTRAL MARIN SANITATION AGENCY

NEWSLETTER | WINTER 2016—2017

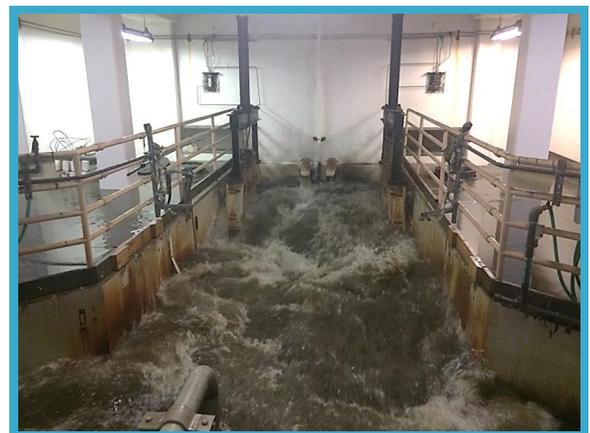
High channel levels caused by elevated influent flows from the Ross Valley and San Rafael interceptors.

The Agency recorded incoming flows as high as 120.5 million gallons per day when a strong winter storm slammed the Bay Area on January 10. It brought gusty winds and a good soaking, continuing a recent pattern of above-average rainfall in our region this season. More debris than normal arrived at the Agency facility, due to the rain scouring the collection system's piping. The influent bar screens were working hard to remove many yards of debris entering the headworks.

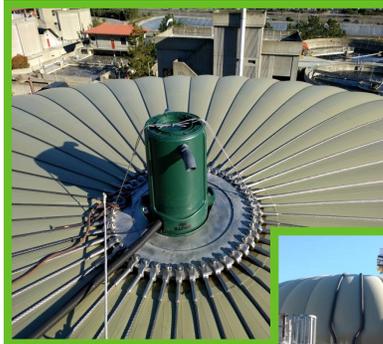
Rough terrain forklift and man-rated basket used to install Laser Level protection system.

Agency digesters have a membrane cover system to store biogas prior to its use as a fuel in the Agency's cogeneration system. Laser level indicators, located on top of and in the middle of the covers, measure and regulate the volume of the biogas. In 2016, the indicator on digester #2 needed replacement and, as these sensitive instruments are subject to the elements, it was determined that rain water was the primary culprit in the level's failure.

Agency technicians came up with the clever idea of housing the indicators inside protective covers to prevent water and sun damage, and to cool these heat-generating units. The efficient

yet cost-effective solution involved customizing two 30-gallon heavy duty plastic garbage cans to do the job.

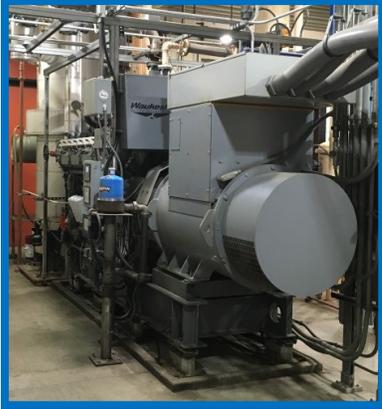
Agency's existing cogeneration engine.

The Agency's cogeneration system, using biogas as fuel, powers the Agency facility over 23 hours per day. In the near future, there may be additional biogas generated to fully power the facility *and* supply excess power to the electrical grid. In order to do so, CMSA is in the process of

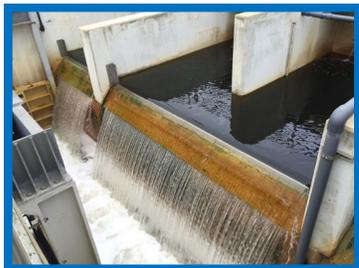
New weirs in service.

Technical Services staff report final effluent flow data to the Regional Water Board in monthly Self-Monitoring Reports. That flow is measured using weirs at the end of the Agency's six chlorine contact tanks (CCT). During maintenance activities in the fall of 2015, staff noted an appreciable increase in measured flows when only two CCTs were operated instead of typical four tank operation, which shouldn't happen. One contributing factor to the flow

variation was determined to be the configuration of the existing weirs.

In 2016, new weirs were installed and a study was initiated to compare the new weir flow measurements to the highly accurate flow monitors that were

temporarily installed in key locations. The study determined that the new weirs consistently measured flows approximately 20% lower than the temporary meters. Staff has reported this issue to the Regional Water Quality Control Board and the Agency will modify the weir flow measurement equation to account for the 20% differential.

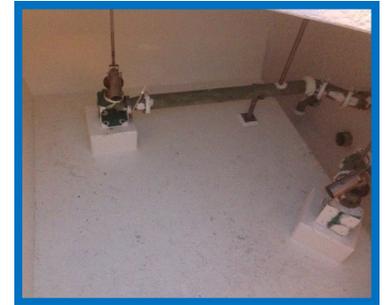
Vault with new epoxy coating.

The Organic Waste Receiving Facility (OWRF) vault originally had a polyurethane coating applied on the interior surfaces to prevent erosion of the tank's concrete floor and walls. This coating did not properly adhere to the surfaces, and over time, the coating failed on the floor and on several wall locations.

In September 2016, a coating contractor was hired to remove the existing coating and re-coat of all interior concrete and any damaged areas on metallic surfaces with an epoxy coating. While the vault was out of service for the work, a temporary

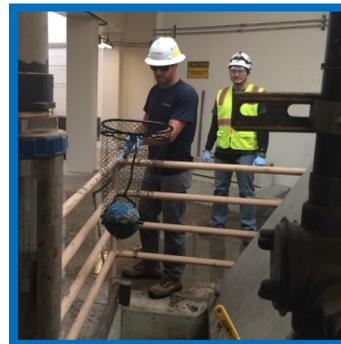
SmartBall rescue from headworks.

under pressure, new inspection technologies were evaluated, and the *SmartBall* was chosen for use in the assessment work. The *SmartBall* is able to identify leaks and locations where air could accumulate in the pipeline which can cause capacity restrictions and lead to corrosion.

Preliminary data received from the San Rafael interceptor inspection found no leaks and one possible air pocket. The results of the Ross Valley interceptor inspection will be available soon.
