CENTRAL MARIN SANITATION AGENCY

NEWSLETTER | SPRING 2019

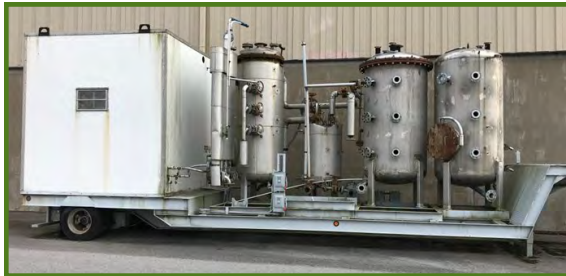
Pilot study digesters and related equipment.

FOG and food waste feedstocks at a loading rate that is approaching published industry thresholds for stable digester operations, and CMSA may need to exceed these thresholds to increase its renewable energy production. A pilot study was recommended to determine the loading rate thresholds under CMSA's actual operating conditions. Staff is procuring pilot equipment and preparing a detailed study plan to test the thresholds. The pilot equipment will be operated by staff and the study is expected to begin in spring 2019 and take up to nine months to complete. Three wastewater engineering and technology firms with extensive national and international expertise in anaerobic digestion have volunteered to participate at no cost as an outside Technical Advisor.

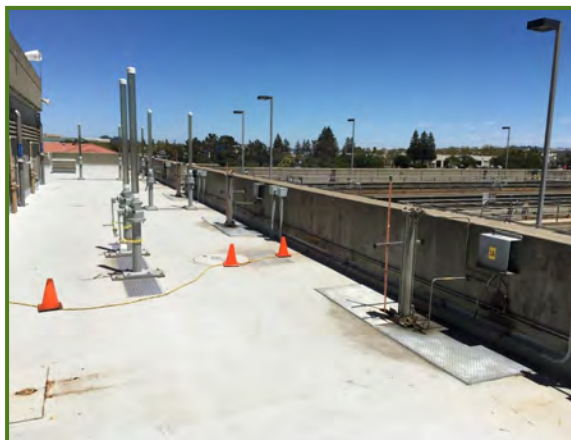
Existing hydraulically-operated primary clarifier gate systems.

The plant's large primary clarifier gates are critical, as they direct flow into individual tanks. Ten of these gates are still opened and closed with the original hydraulic actuator systems that were installed in the 1980s, and need replacement. A project was designed by staff to replace the existing actuators with modern electric actuators that match those already installed in the treatment plant. The project advertisement started in mid-February and bids are due in March. The contract work is scheduled to be completed by the end of this summer.

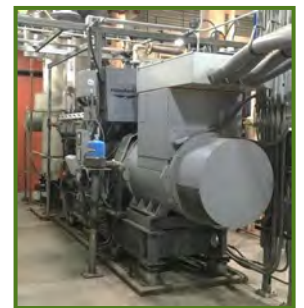
CMSA's cogen engine.

CMSA's cogeneration engine powers the facility. Our Capital Improvement Program includes a project to install a new cogeneration system to improve reliability and efficiency, and to facilitate the sale of excess power generated from increased biogas production.

The first step is developing a pre-design of the new system. An engineering consultant was hired in October, and an alternatives analysis was recently completed. The recommended technology is an internal combustion engine based system—it's the most financially attractive option, has the highest electrical efficiency, and staff is familiar with its operation and maintenance. The pre-design work and evaluation of the air permitting and environmental documentation requirements have begun, which are being funded by a planning grant from the State Water Resources Control Board.

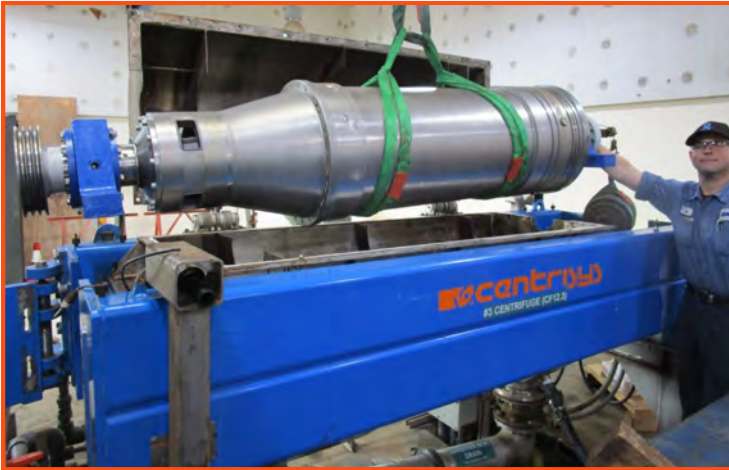
CMSA utilizes centrifuges to dewater biosolids prior to off-hauling for beneficial reuse. This equipment rotates at very high speeds, typically 2,500 rpm, to achieve the separation of liquid from the solids. Rotating assemblies periodically undergo factory maintenance to repair the hardened surfaces and replace discharge nozzles and broken tiles. Last fall, technicians removed the rotating assembly from Centrifuge No. 1 and shipped it to the manufacturer's repair facility for refurbishment. While offsite, staff cleaned the assembly's carriage, performed maintenance on the hydraulic back drive, and replaced lubricants. This work has added an additional five years of service life to the centrifuge.

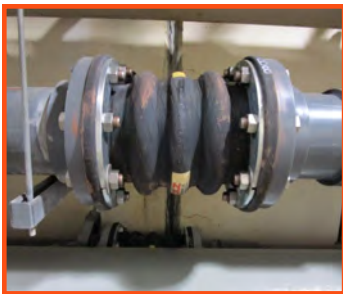
Expansion joints are installed throughout the treatment plant, and this is the second year in a multi-year project to replace these stress relieving devices. Technicians recently removed and replaced fourteen expansion joints in the Agency's underground

gallery system. Each joint, during its original assessment, received a unique alpha-numeric identifier to ensure the proper material of construction, size, and location were noted for the installation technician.

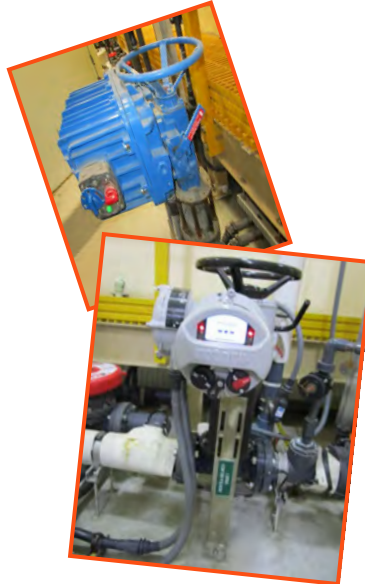
CMSA uses Motor Operated Valves (MOV) to locally and remotely open and close valves and gates. Staff recently replaced two MOVs on each sodium bisulfite storage tank. The existing valves (blue) had been in service for twenty years, were no longer supported by their manufacturer, and parts were difficult to source. Installation of the new valves (gray) was performed in stages to eliminate disruptions to treatment operations.

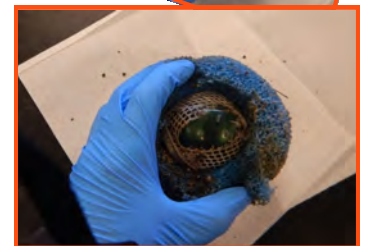
A "Smartball" is a device used to detect water leaks and gas pockets in pipelines, assisting with short-term repair and/or long term asset management. In December, CMSA collaborated with the San Rafael Sanitary District (SRSD) in launching a Smartball into a forcemain for condition assessment work. SRSD tracked the device remotely and planned to retrieve it from the CMSA headworks, but the SmartBall got hung-up somewhere along the line. Ten days later, it was retrieved by an alert operator in an influent screening bin. The ball was promptly returned to SRSD to retrieve the data and learn the story of its adventure.

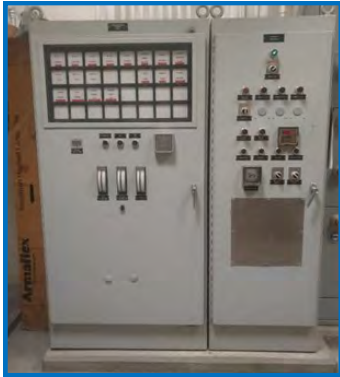
Existing control cabinet at SQPS needing replacement.

FY 20 projects include replacing both motor control centers and the old control systems with a modern PLC-driven system. FY 21 improvements involve replacing the emergency generator and the supply and exhaust fans.

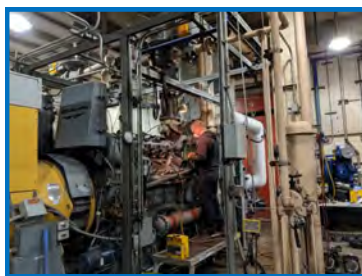
Waukesha engine overhaul.

The cogeneration system consists of a 1,049 horsepower Waukesha internal combustion engine coupled to a 750 kW electrical generator. The cogeneration system supplies power to the Agency's treatment facilities and buildings, and has been in full-time operation since 2005. Waukesha recommends a "top end overhaul" every 15,000 operating hours.

A Waukesha-trained service contractor was recently hired to perform the overall that will increase the reliability and extend the service life of the cogeneration system. Work began in early February and will be completed by March.

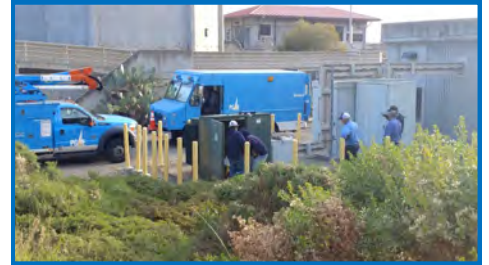
PG&E workers performing a ground-fault detection procedure.

connection Agreement and a Power Purchase Agreement with MCE. The agreement requires improvements to the Agency's electrical and control systems to protect the PG&E utility grid during a power outage. Those improvements were recently completed, and on January 31 the Agency successfully completed a PG&E witness test to ensure that all of the installed equipment meets PG&E's expectations.

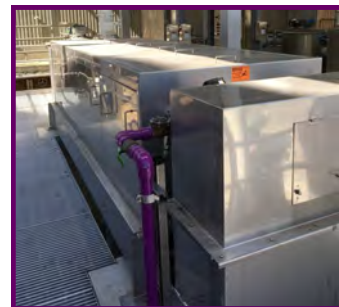
Rotary drum thickeners, one of the many Agency assets.
