## Treatment Plant Activities

## FALL 2012

## Central Marin Sanitation Agency

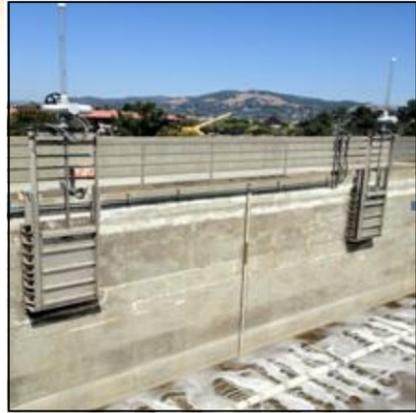
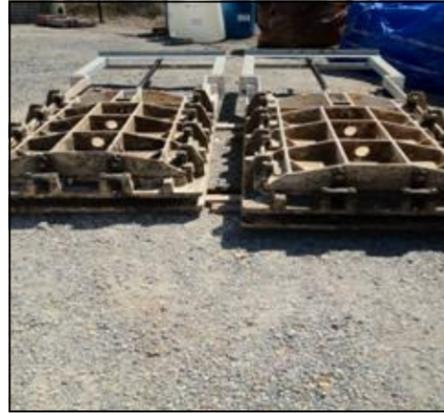
Two **influent sluice gates**; far left, in Aeration Basin #4 were replaced this month. Originally scheduled for replacement in FY12, the CIP team decided to bundle this gate installation work with a small project to replace return activated sludge headers in the same area. The cast iron gates; right, were at the end of their life cycle and could not be repaired. "Bolt on" stainless steel gates were chosen because the price of stainless steel gates was half the cost of iron gates.

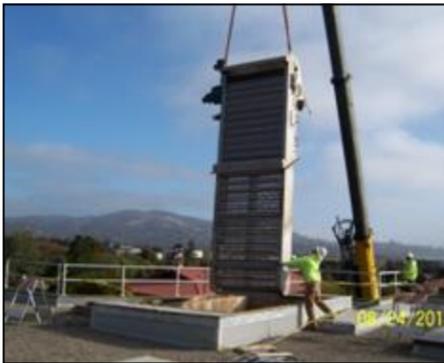
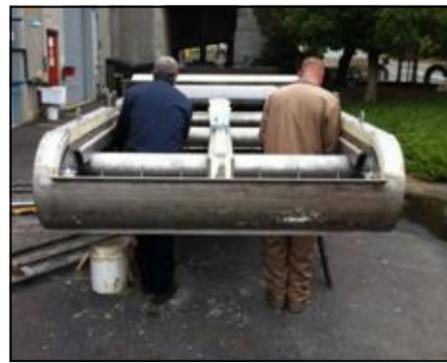
Staff discovered early signs of chain wear and corrosion on both **Headworks filter screens** in 2011. The physical screens are made out of stainless steel and were assessed to be in perfect shape. The originally installed chains and sprockets, however, were made from mild steel with an anodized coating which was beginning to fail. The Capital Improvement Team decided to fund a FY12 project to purchase and install stainless steel wetted "submerged" parts to avert a potential failure. The photos above show the first screen being removed from the influent channel. The other photo depicts CMSA mechanical technician Abel Villarreal working alongside a manufacture representative dismantling and reinstalling the new parts. Both screens were removed, reequipped, and reinstalled into their respective channels.

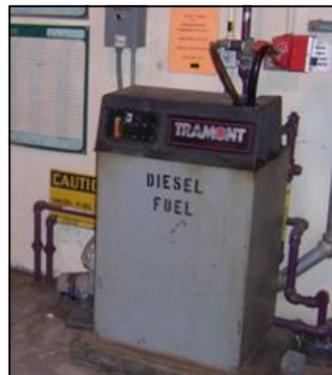
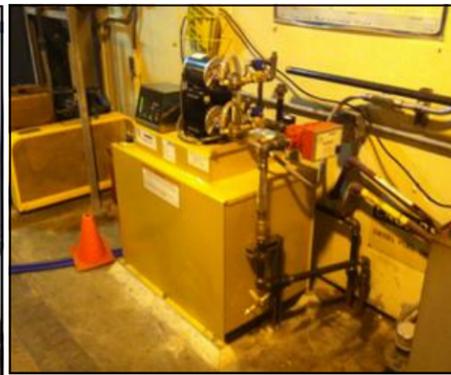
In August, Maintenance staff installed a **replacement diesel fuel storage "day" tank** for the Cummins emergency generator. This tank is meant to provide an initial 55 gallon fuel source when a power failure occurs. As the emergency generator begins to supply power to the Agency, an electronic fuel pump inside this tank ensures a steady supply of diesel is fed from the main 5000 gallon bulk diesel tank to the emergency generator. The original day tank was 28 years old and subject to intermittent failures as it reached the end of its useful life. Pictured, far right, is the replacement of the old fuel tank.

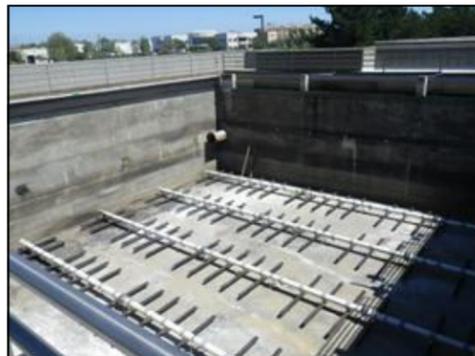
Operations staff is replacing the **fine bubble diffuser** (left) membrane's in Aeration Basins 1 & 4. Aeration basins 2 & 3 will have their membranes changed out as soon as the gate and pipe requirement work is completed in Tanks 1 & 4 and these tanks are brought online.

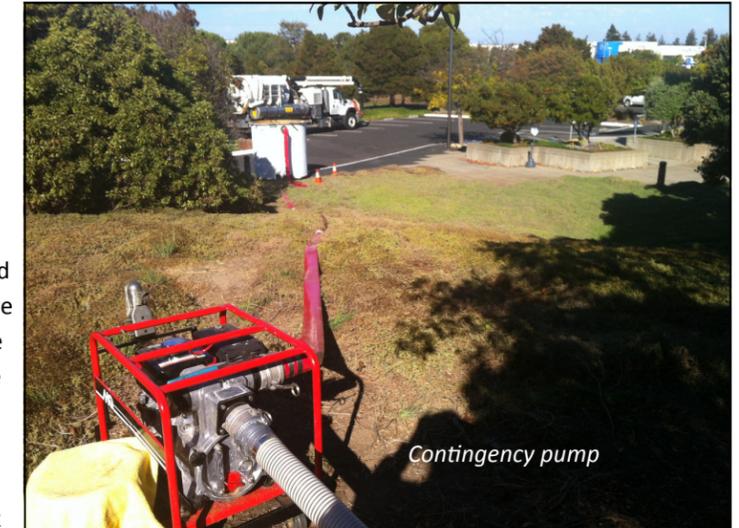
Contingency pump

abandoned). San Rafael Sanitary District provided one of the two pumps required for dewatering the

approximate 40,000 gallons of water within the pipe and CMSA provided the second pump. Water from this isolated section of pipe was pumped from the SFJB and San Rafael flow meter vault up and into the CMSA Headworks around the project work area.

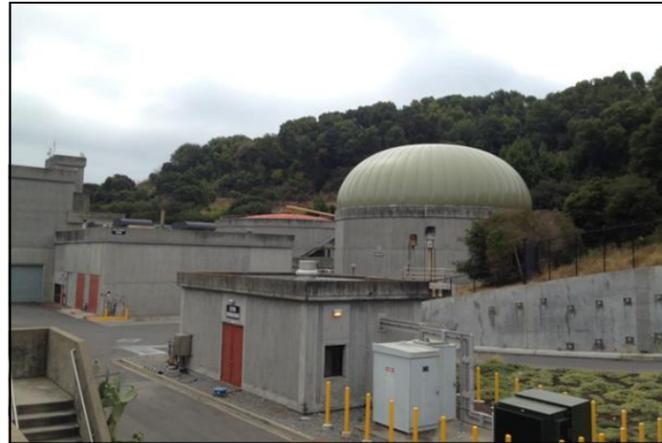
The new membrane cover, above, was installed onto Digester No. 1, and the startup—testing all its controls, filling it with digester gas, and preparing the digester for restarting—will begin soon. The cover is two membranes, an inner gas holder and an outer cover that protects the inner gas holder from the elements and provides controlled air pressure for the gas storage system. Once the cover has been started up and filled with digester gas from Digester 2, Digester 1 will be ready for restarting. Digester restarting involves removing 2/3 of the reclaimed water it was filled with for cover installation, partially refilling it with active sludge, starting the new pump mixing system, bringing the system up to operating temperature, and topping it up with fresh primary and secondary sludge. Digester No. 1's feed rate will be gradually increased during restarting until its digestion and gas production are stable, and it's receiving all of the Treatment Plant's sludge. Once Digester 2 is no longer being fed, it will be ready to be dewatered, so GSE Construction, the prime contractor, can install its pump mixing system and cover. The Agency is investigating the possibility of installing a third mixing pump, to provide full redundancy for this critical process component.

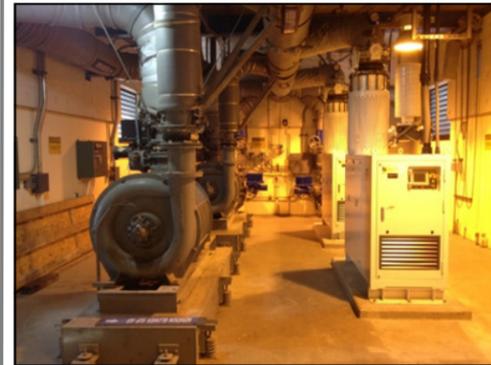
**Aeration Blower Replacement** CMSA utilizes blowers to send air through the Aeration Basins as an oxygen source for the activated sludge treatment process. We replaced two of the four original constant-speed blowers at the plant with new 150-hp variable speed turbo blowers. The remaining two blowers will be used only for backup purposes. The two new blowers were delivered on site in June, Western Water Constructors, the

project's general contractor, completed the blowers' installation in July, and the manufacturer performed the equipment startup in August. Final control integration is due to be completed in September. The new blowers will provide an energy savings because their speed can be adjusted to provide just the right amount of aeration to match the fluctuating activated sludge's

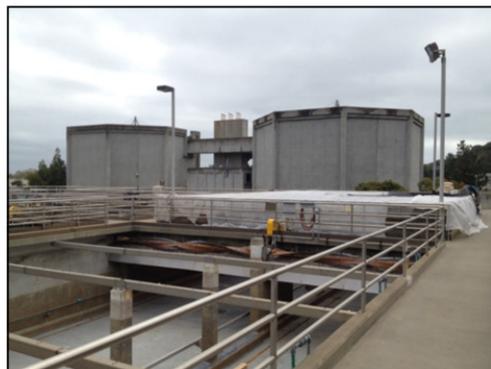
The submerged steel surfaces in two primary clarifiers are being cleaned and recoated. Recoating is scheduled to be completed by Euro Style Management in early October.
