CMSA UPGRADES

Organic Waste Receiving Tank and Biogas Treatment System Upgrades

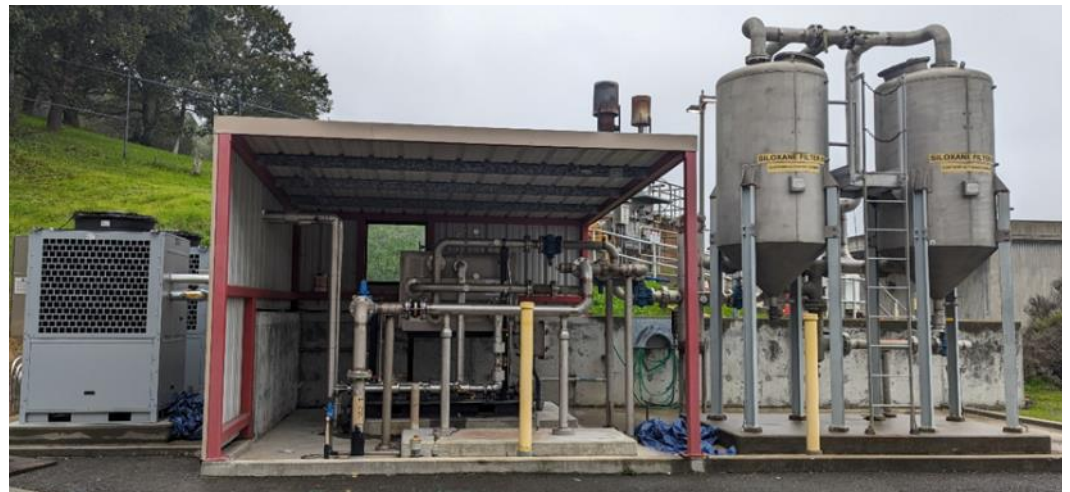
New chillers and heat exchanger for biogas treatment system in service

The upgrades to the biogas treatment system, which included the demolition of the old gas dryer and installation of two new chillers and a heat exchanger, were completed in November 2023. Staff assisted with the programming and shutdown sequencing, and attended the startup and training session with the manufacturer's representative which resulted in a seamless transition to the new system that is currently in operation.

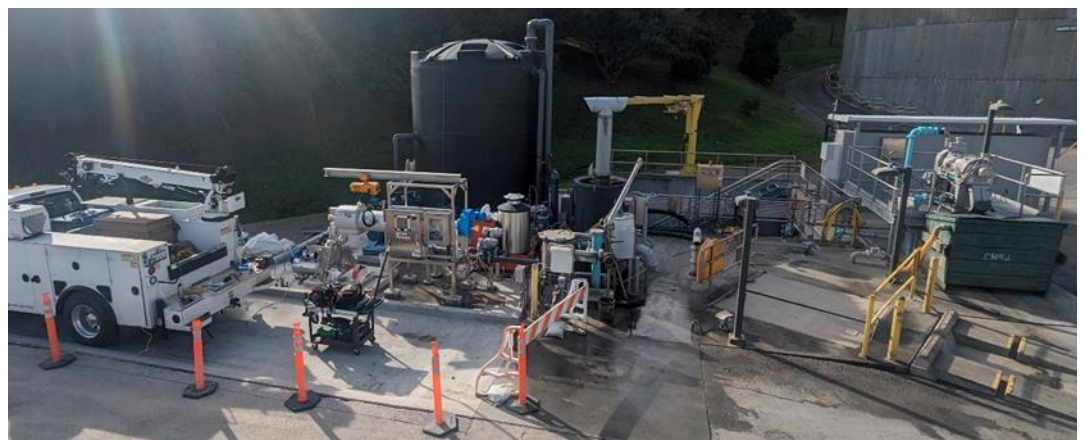
Construction at the new organic waste receiving tank near completion

Remaining work includes making the final connections and startup of the new equipment at the organic waste receiving tank site. The new tank, ladder, seismic anchors, piping, lighting, mixing pump, and screening system have been installed. The proposed receiving station hatch widening work will be incorporated into this project, and completion is anticipated for spring 2024. This project is funded by CalRecycle's Co-Digestion Grant, and to date we have received reimbursement for \$1.73 million of the \$2.5 million awarded for the project costs, including associated CMSA staff time.

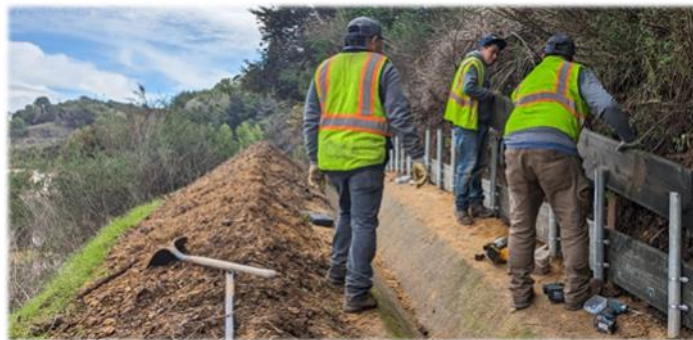
Installation of new retaining wall after clearing v-ditch

In anticipation of wet weather, staff cleared debris from the lower v-ditches on the Andersen Drive hillside and contracted with Forster & Kroeger to perform maintenance of the upper v-ditch, which was extensively overgrown with brush and was packed with soil that prevented proper drainage. Upon clearing the v-ditch, several areas were identified to be susceptible to future slides and therefore additional segments of short retaining walls

were installed as a preventative measure. Separately, Maggiora & Ghilotti was hired to repair hillside damage caused by the 2023 winter storms. Work includes repairing the erosion gullies, installing a retaining wall and earthen berms, and grading and earthwork to prevent future damage for five sites along the hillside.

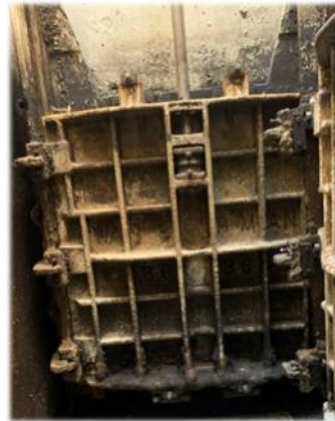
Original installed gate

Staff replaced six sluice gates in the Aeration Basins area this fall. Over the past 10 years, CMSA has been systematically replacing originally installed gates as they reach the end of their working lifespans. This project was challenging, as these gates operate partially submerged, are in a very tight area to work in, and control flow out of the aeration system and into the secondary clarifiers. This required support from several work groups to safely shut down and isolate portions of both systems, while keeping both process areas operational. The original cast iron gates were removed from their frames, and new lightweight stainless-steel gates were installed and then tested for watertightness. Following installation, their actuators were installed and calibrated to ensure that these gates would open and close correctly.

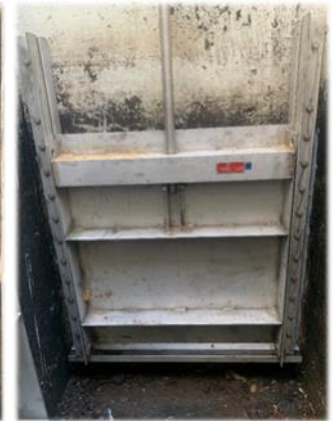
New replacement gate

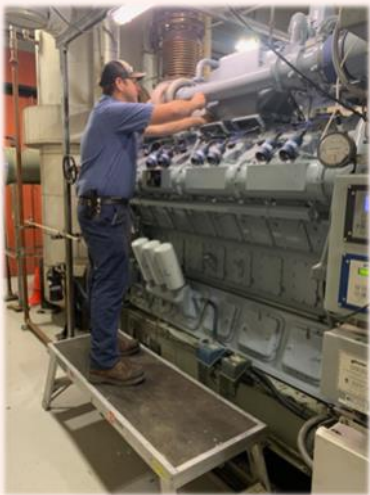
The Waukesha cogeneration engine suffered severe damage in October 2022. The culprit was a main bearing failure due to plugged oil ports. In January 2023, Waukesha Pierce Industries (WPI) has hired to for the repair and rehabilitation work. The engine was removed and taken to WPI's New Mexico facility in February 2023, where it was completely disassembled, and all components were inspected. This project was estimated to take four months to complete, but a shortage in both new and remanufactured parts delayed the rebuild by two additional months. The system was returned, installed, and passed emissions testing in August. This system is now operating, producing green power, and serving as the backup cogeneration system for Agency operations.

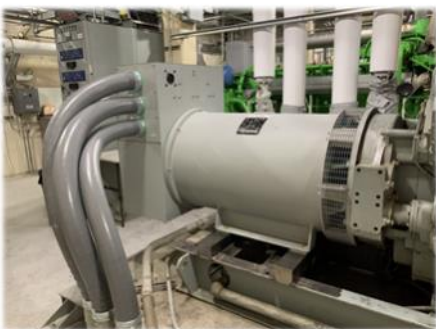
The Cummins emergency standby generator was installed during the Agency's inception and has been operating since 1985. A condition assessment of the generator and the diesel driven engine was performed and its findings indicated that the insulation coating on the generator's windings was deteriorating and recommended recoating them. Staff looked into the cost to reinsulate versus completely replace the generator and found that replacement was the better economic decision. A new generator was purchased, delivered, and installed. Agency technicians installed a new mounting plate onto the existing engine skid and completed the wiring connections between the generator and its control cabinet.
